2005 Buick Truck Rendezvous AWD V6-3.4L VIN E

Drivetrain - Boom or Drone Noise at 2100 RPM

Bulletin No.: 04-04-17-001B

Boom or Drone Noise at 2100 rpm or About 120 km/h (75 mph)
(Inspect and Clean [Torque Tube](#) Mount or Install Dampener/Mount Kit)

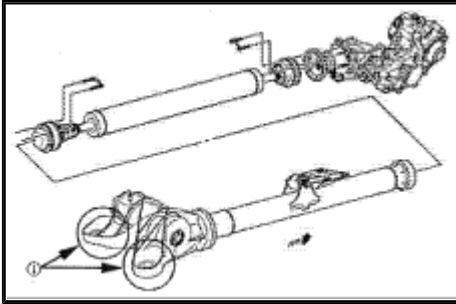
Vehicles that have been operated on dirt roads or in loose dirt may experience a condition called "mud packing". If a large quantity of dirt accumulates on the center torque-tube mount, noise and/or vibration may be transmitted to the passenger compartment. The illustration above highlights the areas of concern within the circles. Please inspect and thoroughly clean the areas indicated if required. If a quantity of dirt was found on the mount, please road test the vehicle and confirm that the boom or drone noise has been corrected. If the noise remains, continue with Correction # 2.
